## U.S. Environmental Protection Agency Vasquez Boulevard I/70 Superfund Site Replacement Certificate

VB/I-70 Command Post 10 E. 55th Avenue Denver, CO 80216 This spreadsheet performs screening level calculations to estimate the effect of peeling leaded paint on the average concentration of lead in yard soil 4644 High St.

This spreadsheet performs screening level calculations to estimate the effect of peeling leaded paint on the average concentration of lead in yard soil 4644 High St.

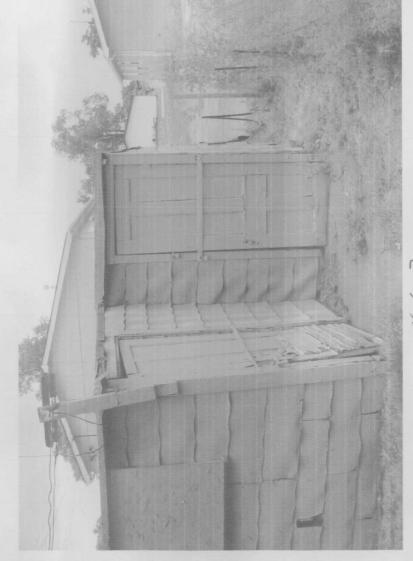
photo 3

Drawing	Photo			-		Percent	_				
Number	Number	Painted Surface	Material	Color	Total Area of Element	Deteriorated	Deteriorated Area	XRF#	XRF Value	pos/neg	Notes
											should be replaced - borderline
6	3	south door, door frame, trim	wood	blue	18.5	100%	18.5	647	0.7+-0.3	pos	reading called positive
7	3	west door, door frame, trim	wood	blue	20.1	50%	10.05	648	16+-7.2	pos	
		north board over window	wood	blue				649	0.03+-0.18	neg	
	·	<u> </u>									
	<u> </u>					ļ		-			
	<u> </u>		<u> </u>			ļ <u> </u>					
<u> </u>			<del></del>						<b></b>		
			<del> </del>		<del> </del>	<del> </del>			<del> </del>		
				<del></del>		<del>                                     </del>		<u> </u>	<del></del>		
			<del>                                     </del>			<del>                                     </del>	·				<del></del> -
<del></del>						<del> </del>	<del></del>				<del>"</del>
									·		
				<del>_</del> .
